TEST REPORT

Report No.: HC20127/2010

Product Description: 20.1 Multimedia LCD Monitor
Style/ Item No.: WMRM920-PIP/ No. 1
Quantity: Total 1 set
Testing Period: Mar. 1, 2010 to Mar. 4, 2010

1. Operating High Temperature test:

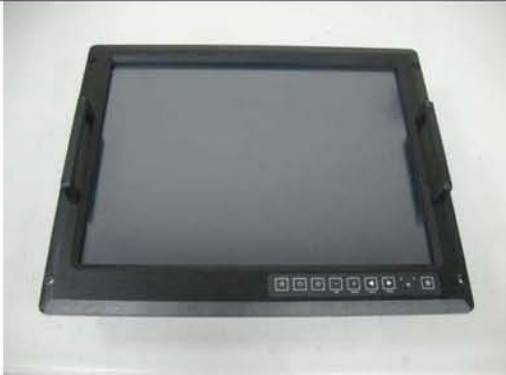
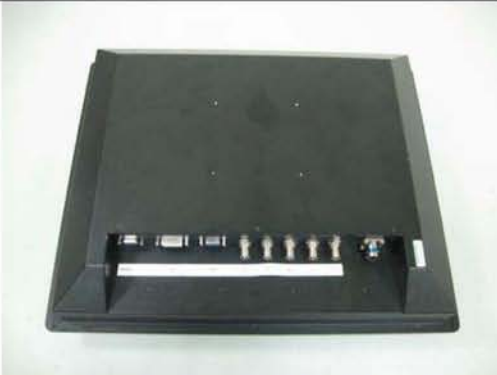
<p>1. Appearance of specimen (WMRM920-PIP)</p>	<p>2. Appearance of specimen (WMRM920-PIP)</p>

Check Item Style/Item No.	Appearance check (Visual check)	Functional Check & Performance Check
WMRM920-PIP/ No. 1	No visible damage	Normal

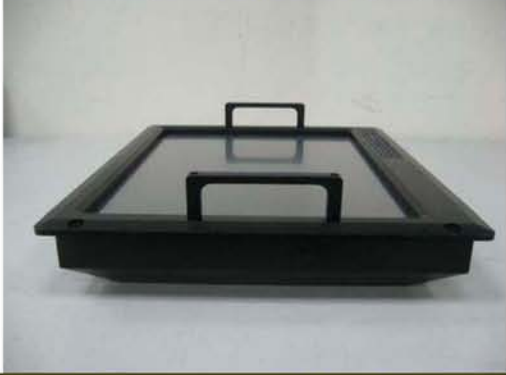
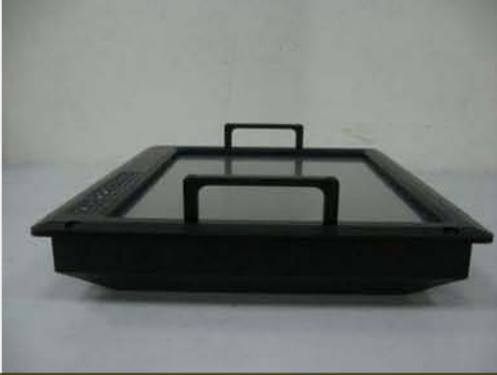
<p>3. Appearance of specimen (WMRM920-PIP)</p>	<p>4. Appearance of specimen (WMRM920-PIP)</p>

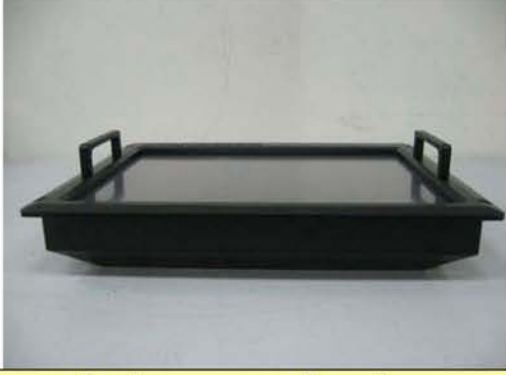
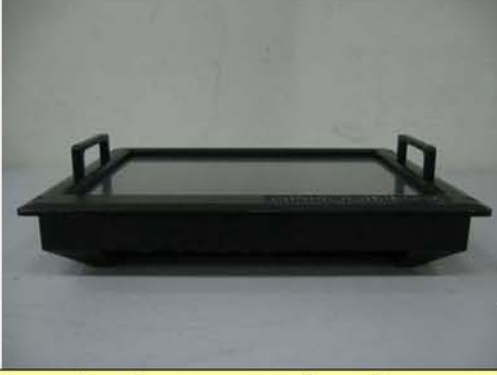
<p>5. Appearance of specimen (WMRM920-PIP)</p>	<p>6. Appearance of specimen (WMRM920-PIP)</p>
