TEST REPORT

Report No.: HC20131/2010

Product Description: 20.1 Multimedia LCD Monitor
Style/ Item No.: WMRM920-PIP/ No. 1
Quantity: Total 1 set
Testing Period: Apr. 7, 2010 to Apr. 8, 2010

1. Vibration Test

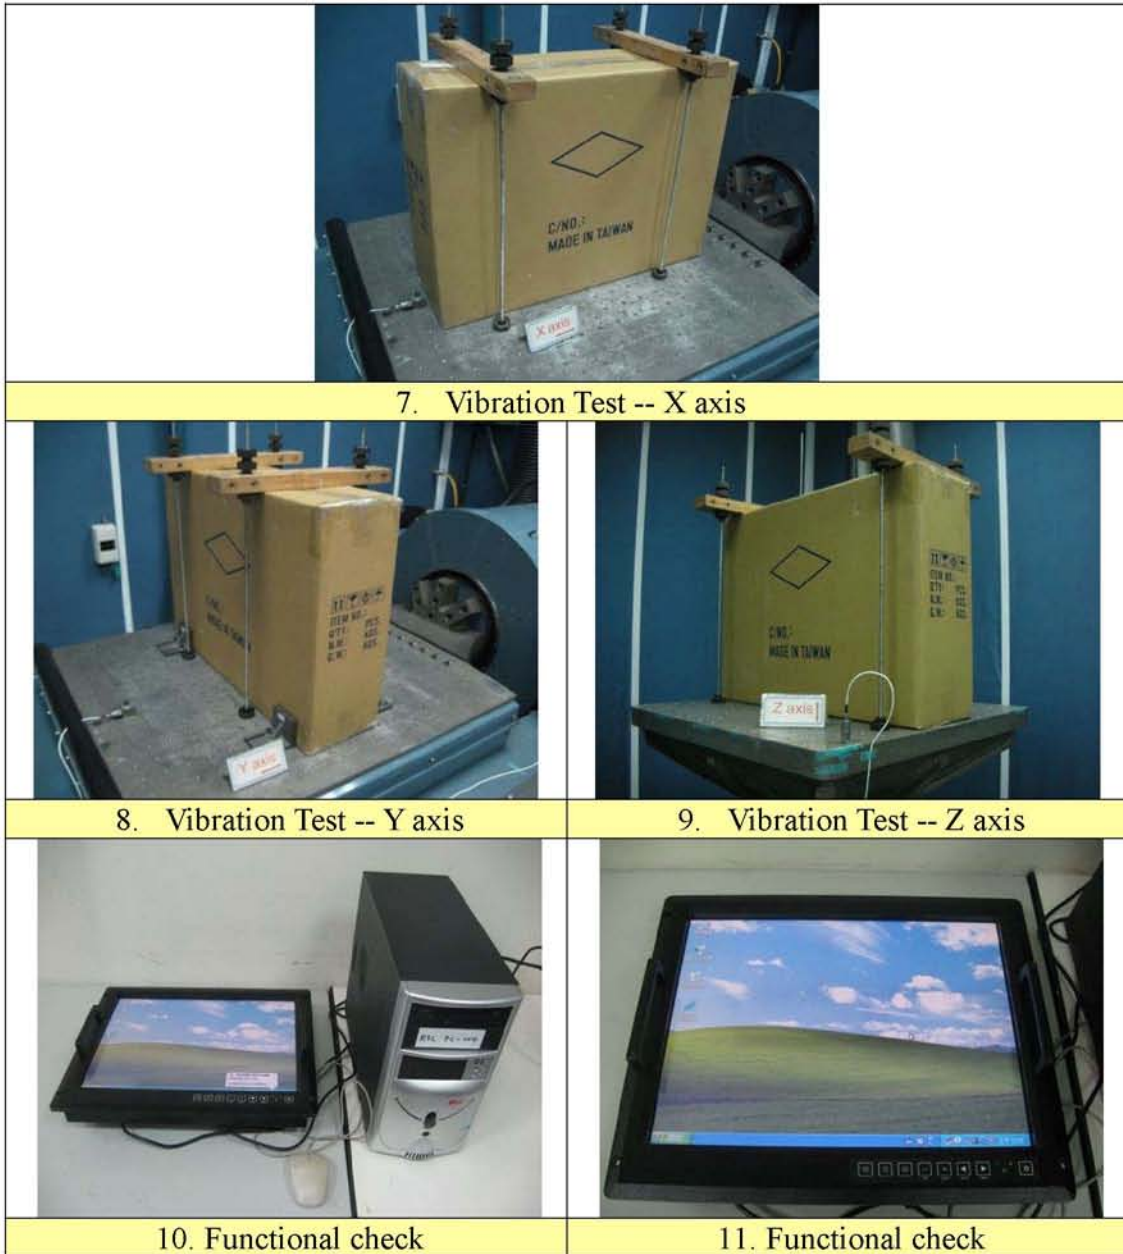
Direction: X, Y, Z axes (See photo 7 ~ 9)
