TEST REPORT

Report No.: HC20136/2010

Product Description: 20.1 Multimedia LCD Monitor
Style/ Item No.: WMRM920-PIP/ No. 1
Quantity: Total 1 set
Testing Period: Apr. 16, 2010

1. Mechanical Shock Test

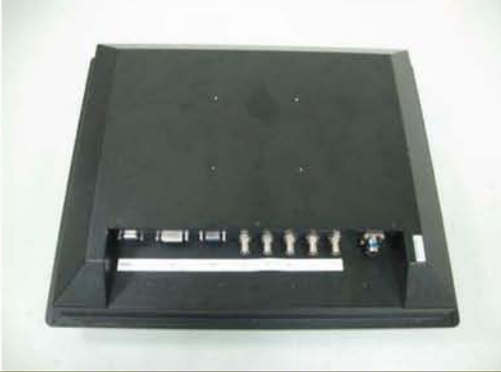
<p>1. Appearance of specimen (WMRM920-PIP)</p>	<p>2. Appearance of specimen (WMRM920-PIP)</p>

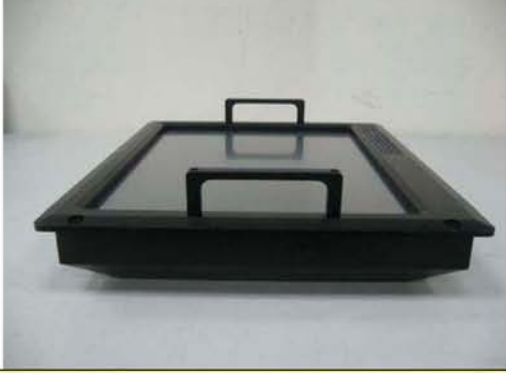
<p>3. Appearance of specimen (WMRM920-PIP)</p>	<p>4. Appearance of specimen (WMRM920-PIP)</p>

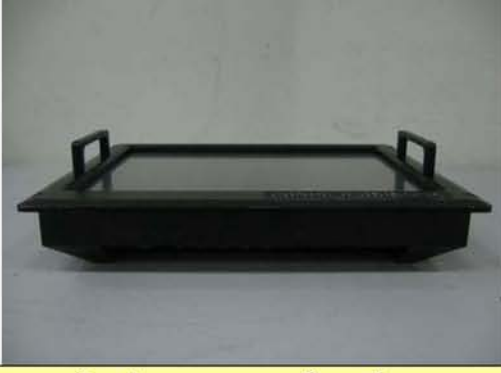
<p>5. Appearance of specimen (WMRM920-PIP)</p>	<p>6. Appearance of specimen (WMRM920-PIP)</p>

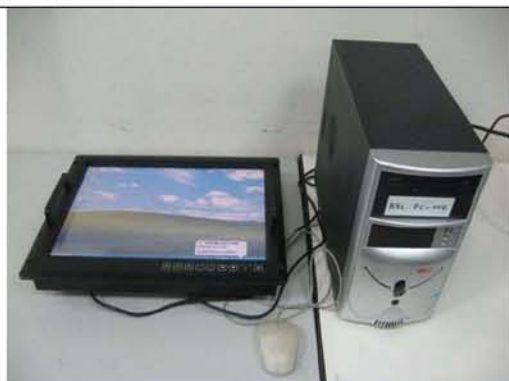
13. Functional check

- Examine the appearance of specimen(s) by visual check and perform functional check after this test.
- Functional check: Connect the specimen with rated power then examine whether the display function of specimen could be work normally or not.
- The equipment, in its operation shock mode, sawtooth waveform, 40g 11ms duration and one shock for each of the six faces & the cycle is 3 times (Total 18 shocks) on testing. Must be free of mechanical structure, operational, functional and the display of key parts have to be normal. Performance check: Running Window XP with stress software BCM diagnostics Pro version 2.30.

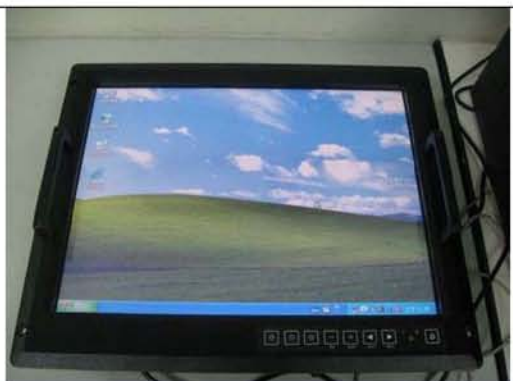
14. Functional check
