## TEST REPORT

Report No.: HC20137/2010

Product Description: 20.1 Multimedia LCD Monitor

1. Thermal Shock Test

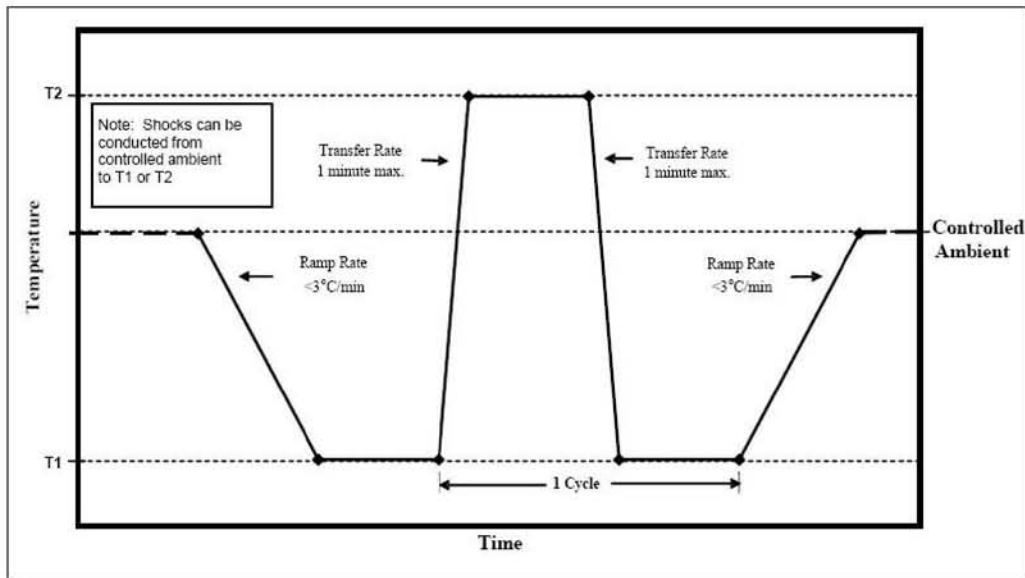
Test method: Reference to MIL-STD-810G, Method 503.5 Testing Procedures I-B, Figure 503.5-2. Single cycle shocks.

Temperature:  $-33$  to  $63^\circ\text{C} \pm 2^\circ\text{C}$

Test duration: 1 cycle

- The following procedures provide the basis for collecting the necessary information concerning the materiel in a severe temperature shock environment. According to method 503.5 / procedure I-B / Figure 503.5-2: Single cycle shocks from constant extreme temperature.

- The equipment shall withstand the required temperature shock conditions and shall meet, without any functional damage, all performance requirements after being exposed to 1 cycle of high-low temperatures, as illustrated in Figure 503.5-2. Performance check: Running Window XP with stress software BCM diagnostics Pro version 2.30.

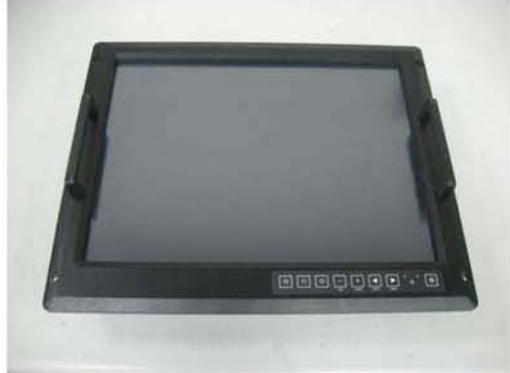
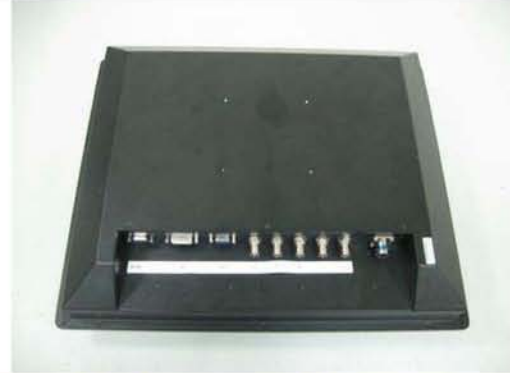
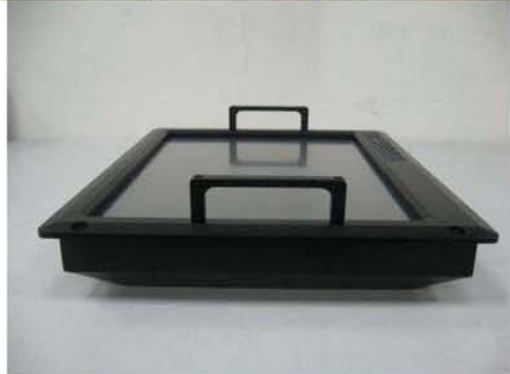
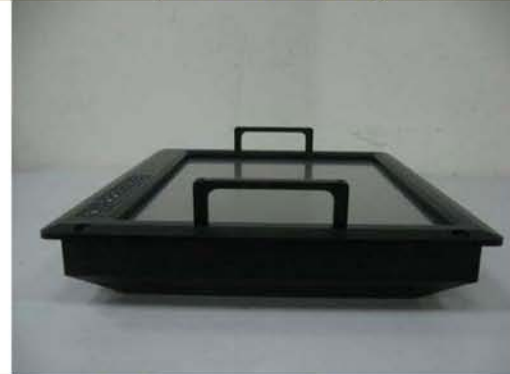
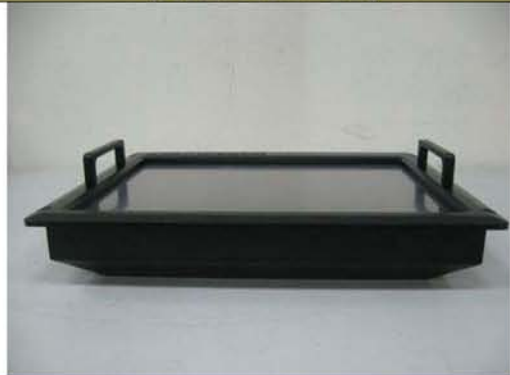
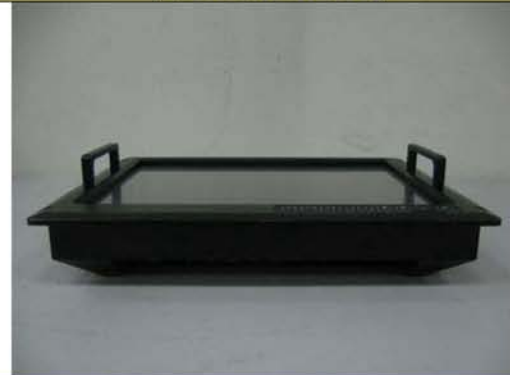
1. Appearance of specimen (WMRM920-PIP)	2. Appearance of specimen (WMRM920-PIP)

<b>Check Item</b> Style/Item No.	<b>Appearance check</b> <b>(Visual check)</b>	<b>Functional Check &amp;</b> <b>Performance Check</b>
<b>WMRM920-PIP/ No. 1</b>	No visible damage	Normal
