TEST REPORT

Report No.: HC20132/2010

Product Description: 20.1 Multimedia LCD Monitor
Style/ Item No.: WMRM920-PIP/ No. 1
Quantity: Total 1 set
Testing Period: Apr. 7, 2010 to Apr. 8, 2010

1. Vibration Test

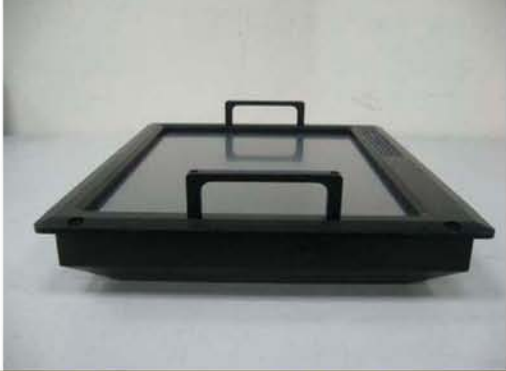
<p>1. Appearance of specimen (WMRM920-PIP)</p>	<p>2. Appearance of specimen (WMRM920-PIP)</p>

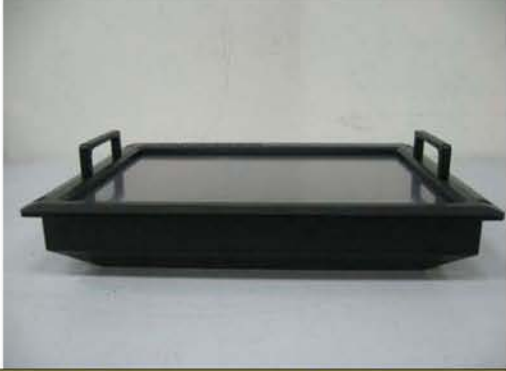
<p>3. Appearance of specimen (WMRM920-PIP)</p>	<p>4. Appearance of specimen (WMRM920-PIP)</p>

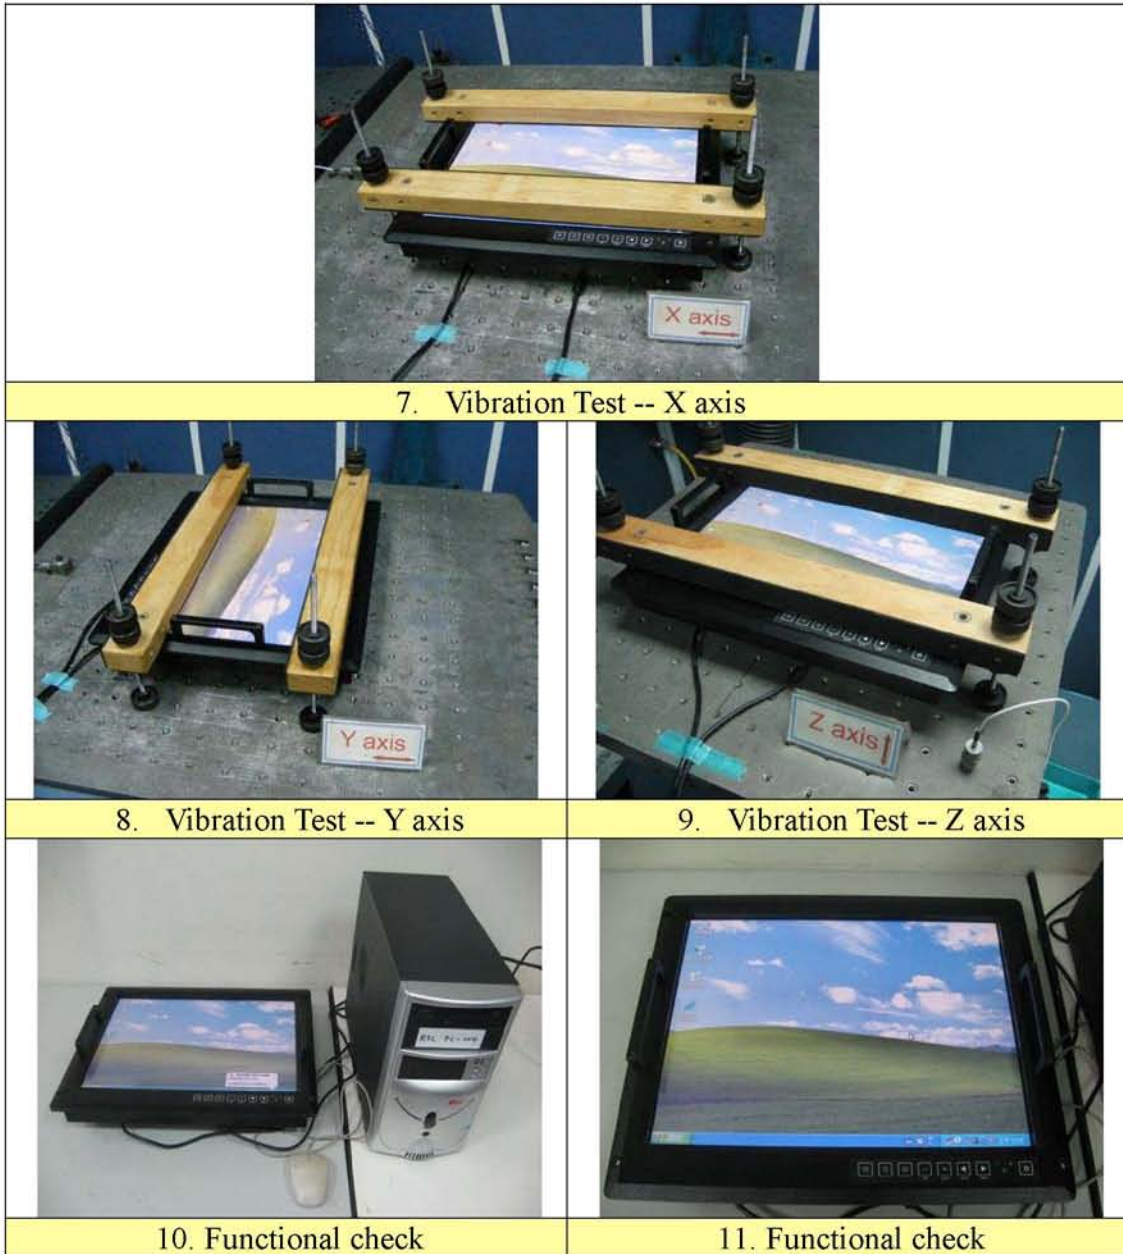
<p>5. Appearance of specimen (WMRM920-PIP)</p>	<p>6. Appearance of specimen (WMRM920-PIP)</p>

Direction: X, Y, Z axes (See photo 7 ~ 9)
